DIABLO CANYON TRANSFORMER FIRE (AGAIN)

In the early hours of Sunday, August 17, 2008, the Unit 2 reactor at the Diablo Canyon Nuclear Power Plant near San Luis Obispo, California automatically tripped from 100 percent power due to a fire at main transformer C. The main transformer (Main Bank Xfmr) increases the voltage of the electricity produced by the main generator from 25,000 volts to 500,000 volts so the switchyard can send the power out via transmission lines to customers.

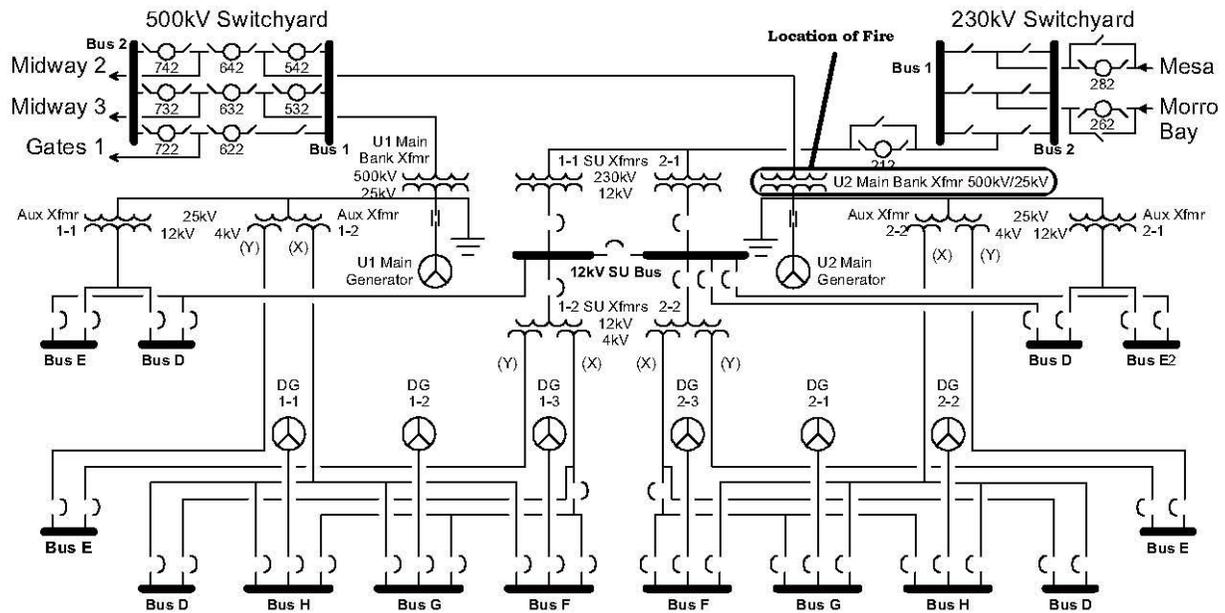
Prior to the transformer fire and reactor trip, the electrical output from the Unit 2 main generator not only went out to the grid via the 500,000 volt switchyard but also flowed back through auxiliary transformers (Aux Xfmr) 2-1 and 2-2 to power internal equipment. After the reactor trip, electricity from the 230,000 switchyard flowed inward through startup transformer (SU Xfmr) 2-1 to power plant equipment. Had the 230,000 switchyard been unavailable or the startup transformer failed, emergency diesel generators (DG) 2-1, 2-2, and 2-3 could have powered essential plant equipment.

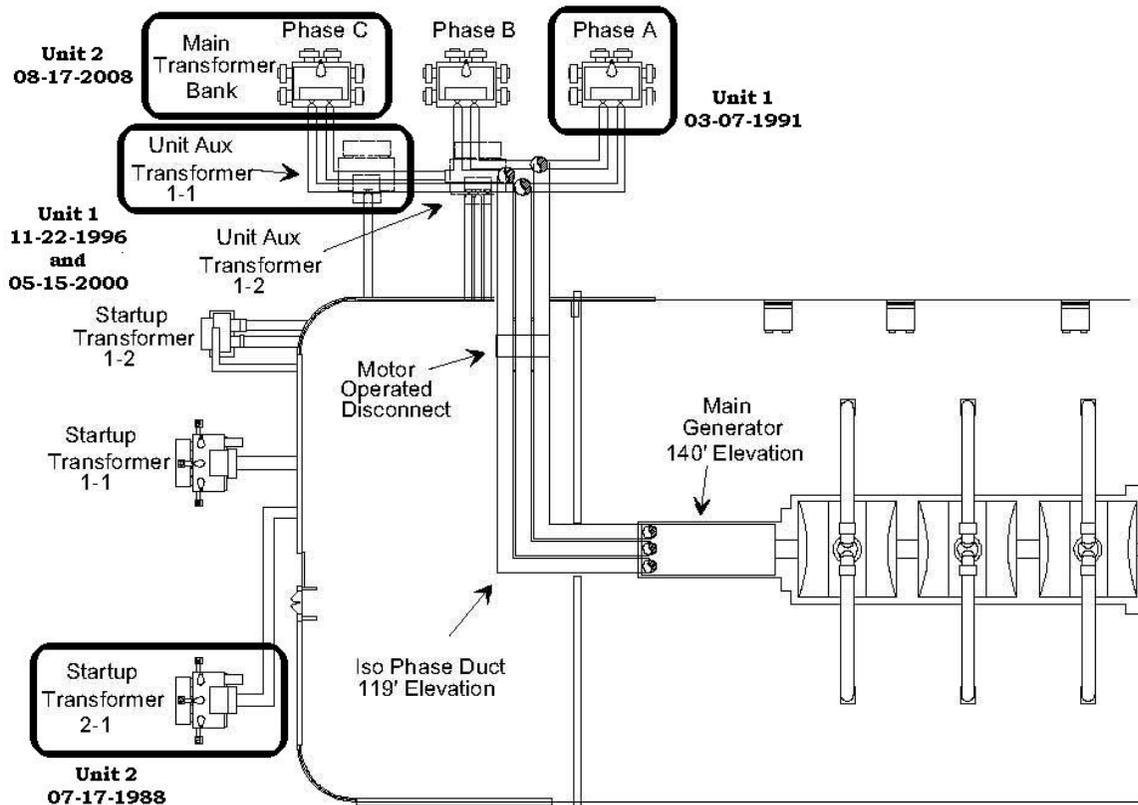
- 03-07-1991: With Unit 1 shut down for refueling a mobile crane damaged main transformer A causing a complete loss of offsite power. The three emergency diesel generators started and supplied the emergency electrical buses. The startup transformer was tagged out for maintenance at the time of the event, preventing offsite power from the 230,000 kilovolt switchyard from powering plant equipment.
- 07-17-1988: The operators manually tripped Unit 2 from 50 percent power when an electrical fault on one of four reactor coolant pumps initiated a transient on the plant's internal electrical buses causing a small fire at the startup transformer.
